# DESIGN AND DEVELOPMENT OF A FLYING OBJECT FOR INSPECTION AND CLEANING OF DISTRIBUTION POWER LINES IN SRI LANKA

**Abstract** - Inspection, detection and cleaning are essential for the maintenance of distribution power lines (DPL). Developed countries use unmanned automated vehicles (UAVs) for this purpose. Helicopter usage is efficient but costly and ineffective for developing countries. Manual inspection and cleaning is the current method used in Sri Lanka. Most research on UAVs in the developing world are at experimental level; practical appliances have been slightly neglected. It is possible to use UAVs to inspect, detect and rectify the issues occur in DPLs in Sri Lanka. This can reduce costs, risks and logistic problems of manual inspection and cleaning. Aim of this project was to design and develop an Unmanned Automated Flying Object (with a Robot Arm) and test its' applicability in inspection and cleaning of DPLs in Sri Lankan context. This paper describes the design and preliminary test results of flying, video transmitting and receiving performances of the Quadcopter. Design of the system architecture of the Quadcopter encompasses a flight control system, Xbee module, in

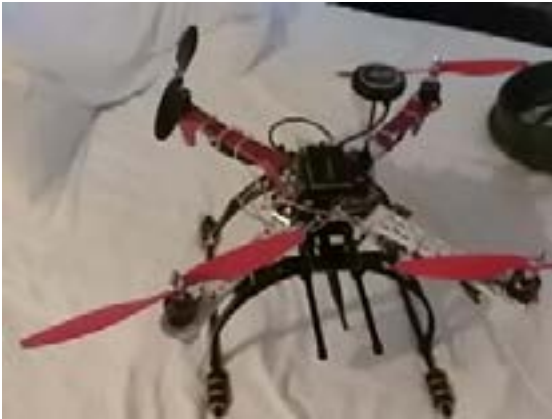
Figure 2: The model aircraft (Quadcopter)

The model aircraft was developed and installed a video data link, HD camera and the Xbee module on it. A practical demonstration was conducted to test the flight control system. The aircraft could fly successfully along a 33kV distribution power line. Total flying distance was about 2 km. Flying route was recorded from the ground station. Practicability of the inspection system was tested by the visual images transmitted to the ground station from the Quadcopter. Figure 2 and 3 show the Quadcopter and the interface of flight control system.

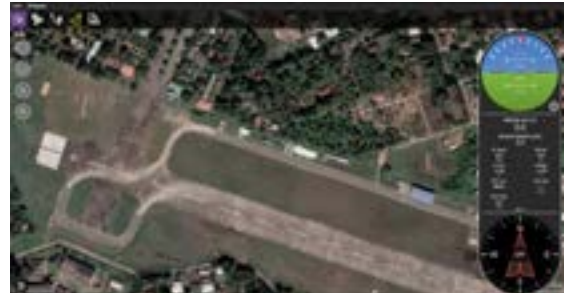
Figure 3: The interface of flight control system
