## AN ANALYSIS OF CAUSES OF COASTAL EROSION IN CALIDO BEACH, KALUTARA, WEST COAST OF SRI LANKA

### ABSTRACT

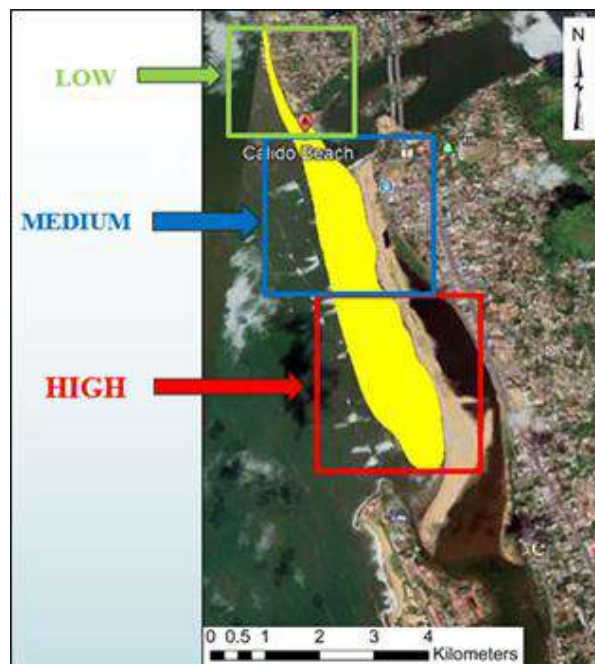
According to the analysis of shoreline changes between 2004 and 2020, it has been classified the eroded area as high, medium, and low (Figure 4).

Figure 4: Spatial distribution of beach erosion in Calido

Therefore, the study was revealed that the total extent of the eroded area of the Calido beach was approximately 0.45 km<sup>2</sup>. Also, the length of the eroded area was approximately 3 km, while the perimeter was about 5.52 km.

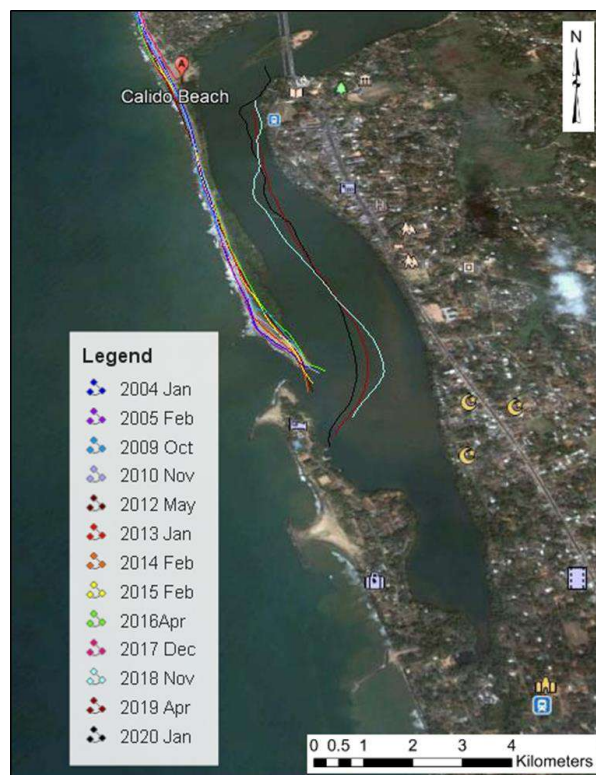
shoreline position (Chand & Acharya, 2010). The waves generated by the wind are one of the most important energy transfer agents along the Calido coastline. These waves emancipate their energy by striking the coast and setting up the erosion of cross-shore and alongshore. There is no significant change of shorelines in the early years. It is a regular pattern. However, shorelines are significantly changing yearly after the year 2017 (Figure 12).

Figure 12: Annual shoreline changes in Calido beach

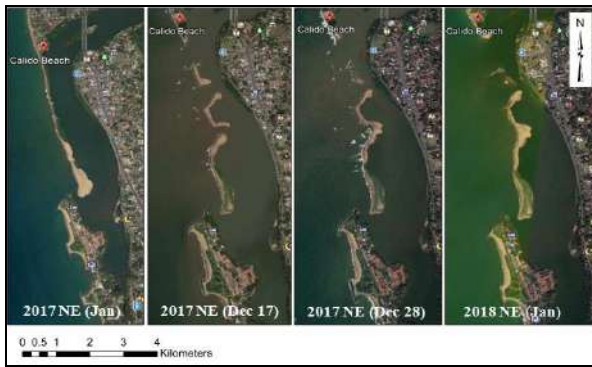
Accordingly, it can be observed that the sand deposition is higher on December 28 than it was on December 17. In January, it was even more so. According to these figures, it can be concluded that predominantly sand deposited during the northeast season (Figure 13).

In February, it can be seen that the sand deposition was even higher. The formation of the sand bar changed after the southwest monsoon period. The southwest monsoon may have contributed to this change, as heavy rainfall and higher wave height of waves occur during this monsoon.

Figure 13: Seasonal shoreline changes during 2017 & 2018

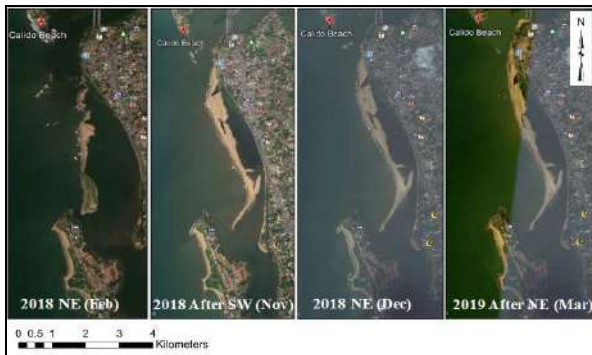
Comparison of these images indicates that some areas are newly deposited, and some areas are eroded. Constructive waves can cause to erode some areas because their strong backwash will result in beach erosion. Also, cross-shore sediment transport and alongshore sediment transport may cause the new deposition. Because of increasing the river flow, the sand supply from the river is increased (Figure 14).

Figure 14: Seasonal shoreline changes during 2018 & 2019

These images clearly show that the direction in which the new sand is deposited is the same as that on the sediment transport map around Sri Lanka. By considering all these figures, it can be concluded that the developing rate of sand bar is less during the southwest monsoon and predominantly sand deposited during the northeast monsoon. Hence, the southwest monsoon and northeast monsoon are the critical seasons. However, these are only seasonal changes. It gets recovered and deposited after the season (Figure 14).

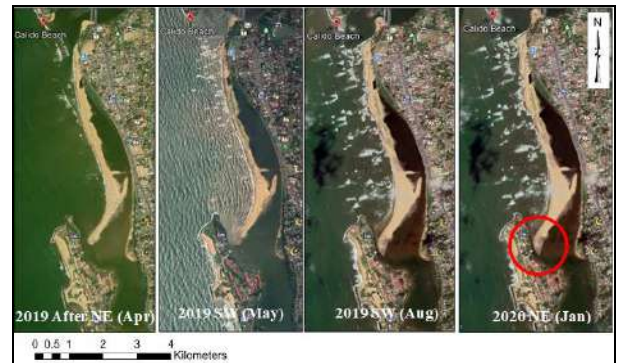
Another important fact that can be seen in the study area is the sediment cell developing in the sand bar (Figure 15).

Figure 15: Seasonal shoreline changes during 2019 & 2020

Sediment cells are the movement of material that is largely self-contained. Also, if the dune in the lagoon area (the area surrounded by red color in the fourth image) is covered, another huge problem will arise. It can occur water quality problems because people who live in this area normally put garbage in the water and no circulation if it is closed.

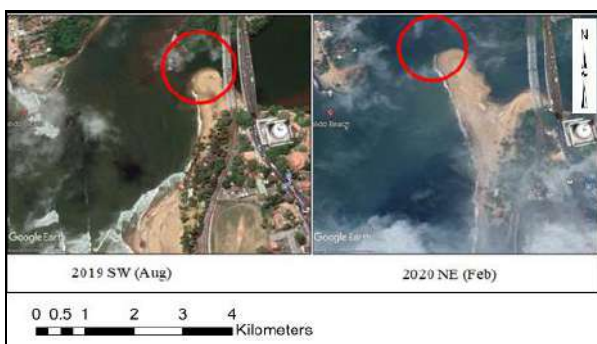
Although, the gradual expansion of the sand bar toward the sea can be identified in northeast season in 2020 (Figure 19). However, it is a serious problem as it is more difficult to drain the water from the mouth of the river. Then again this area will be eroded.

Figure 19: Seasonal shoreline changes during 2019 & 2020
